Stormy Lake 2023 Lake Assessment Report

Prepared by
Vilas County Land & Water Conservation

September 11, 2025

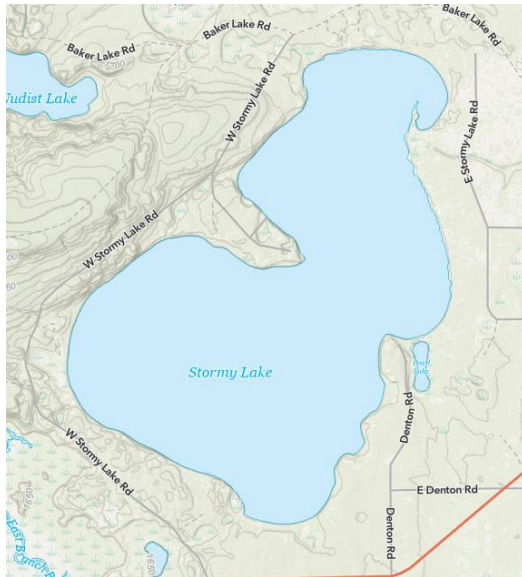
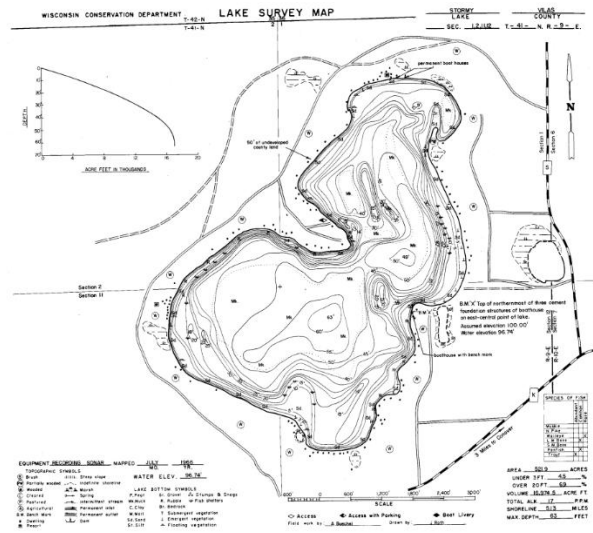
Figure 2. Stormy Lake area topography map with 10 ft contours. Moderately steep slopes exist on the western shoreline. Image courtesy of Vilas County Geospatial Online. The bathymetry map shows steep drop offs around much of littoral area, except for the north bay. Bathymetry map courtesy of WI DNR.

A topographic map shows that the western shoreline is moderately steep, between 6-15% (Vilas County Geospatial Online). The bathymetry map shows the lake drops off steeply, except for the north bay.

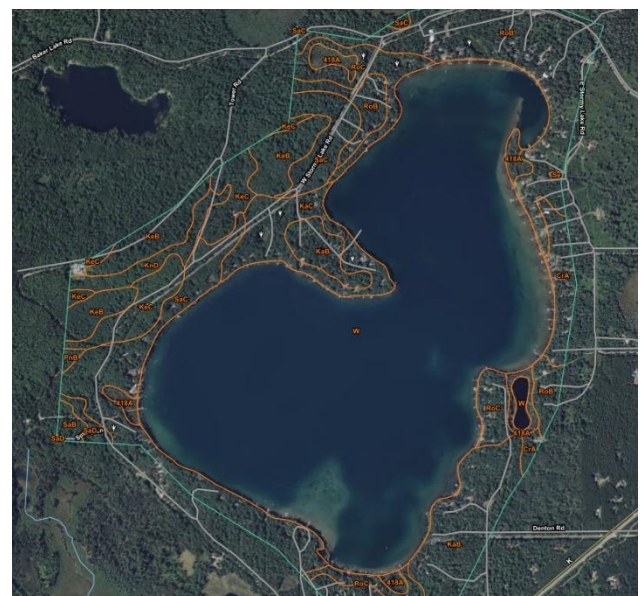
Figure 3. Many different soils occur around Stormy Lake, and about half are greater than a 6% slope. Soils making up more than 5% of the watershed include: Rubicon sand (Ro) with slopes between 0-15%; Sayner-Rubicon complex (Sa) with slopes between 6-15%; Karlin loamy fine sand (Ka) with slopes 0-15%; Siskiwit-Vilas complex (Ke) with slopes 6-15%; Keweenaw-Sayner-Vilas complex (KeC) with slopes 1-15%. Courtesy Web Soil Survey.

Soils with slopes greater than 6% (ie. for every 3 ft change in elevation, there is 50 ft horizontal distance) make up approximately half of the surrounding land; sandy soils up to a 6% slope make up just over 40% of the surrounding land; and level mucks and peats make up the remaining 4% of the surrounding land. The steeper sandy shorelines primarily located on the west and south sides of the lake would be moderately vulnerable to soil erosion (*Web Soil Survey*).

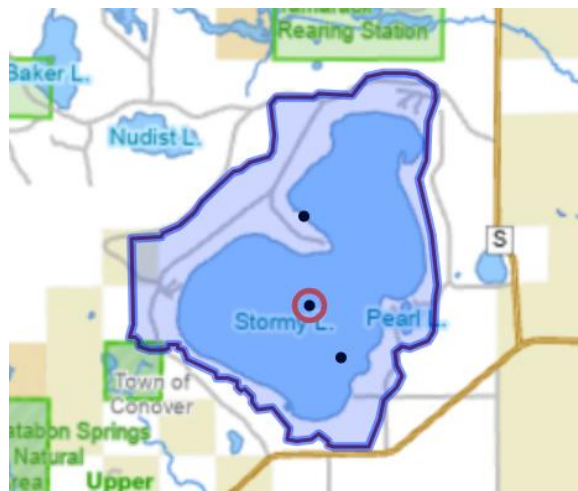
Figure 4. Stormy Lake has a small 1.49 sq. mile watershed (including the lake itself). Image from WI Water Explorer.

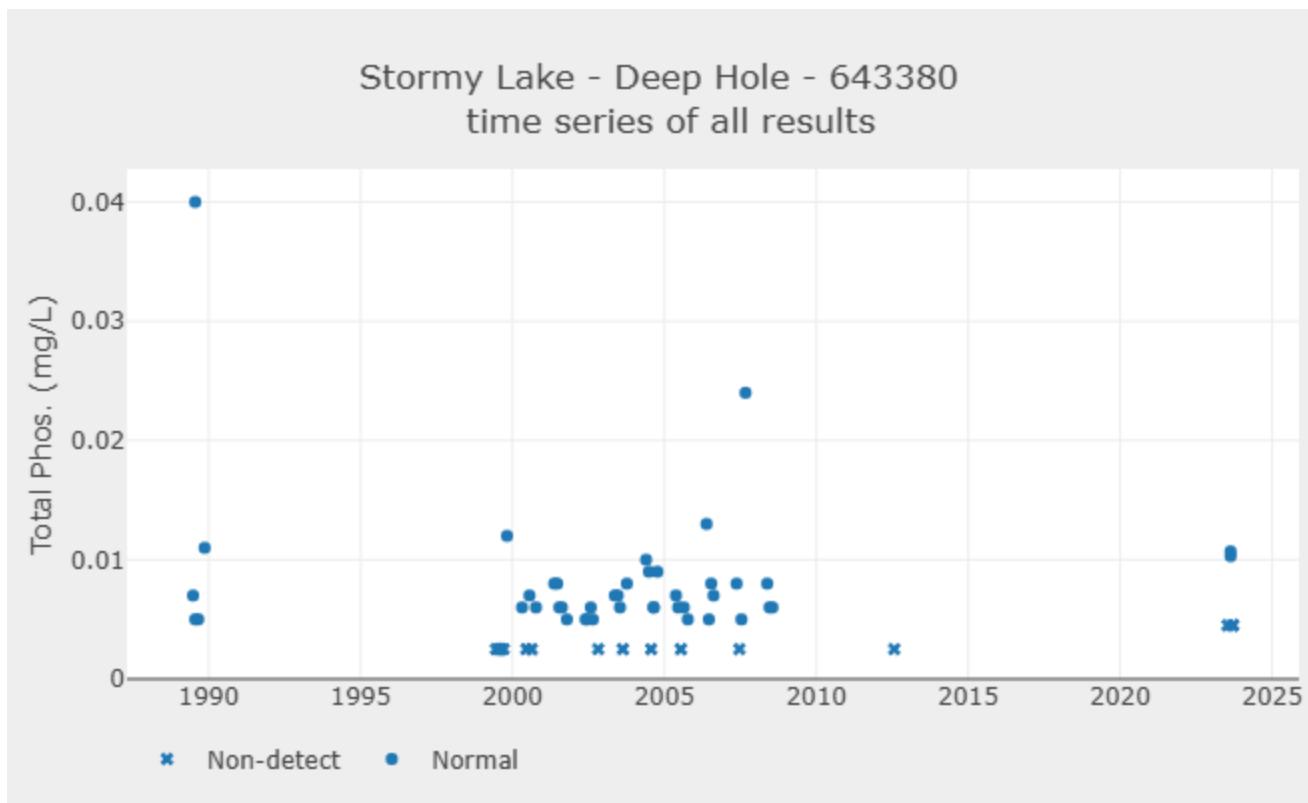
Figure 5. Stormy Lake total phosphorus data from 1989-2023. No statistically significant trend was detected. Notice y-axis lists mg/L, so the two-story fishery lake threshold criteria would be at 0.015 mg/L (vs. 15 ug/L). Plot generated from the Wisconsin Water Explorer.

Phosphorus is an element needed for plant growth, including aquatic plants. Other nutrients plants need include nitrogen and carbon. Lakes usually have plenty of both carbon and nitrogen, so in roughly 80% of Wisconsin's lakes, phosphorus is the element that limits excessive plant and algae growth. For two-story fishery lakes like Stormy Lake, the total phosphorus criteria for both fish & aquatic life and recreation is 15 ug/L. The total phosphorus sampled on Stormy Lake did not exceed that criteria on any of the 3 sampling events in 2023. The mean total phosphorus reading from the 3 sampling events in 2023 was less than 10.3 ug/L. Two of the samples could not detect phosphorus in the water, but the limit of detection is at 9 ug/L. The remaining sample result was 10.3 ug/L. Historic total phosphorus data between 1989-2023 show that most results were under the WISCALM threshold of 15 ug/L. Total phosphorus does not currently show any statistically significant trends detected for decreasing or increasing total phosphorus on Stormy Lake (Wisconsin Water Explorer). See figure 5.

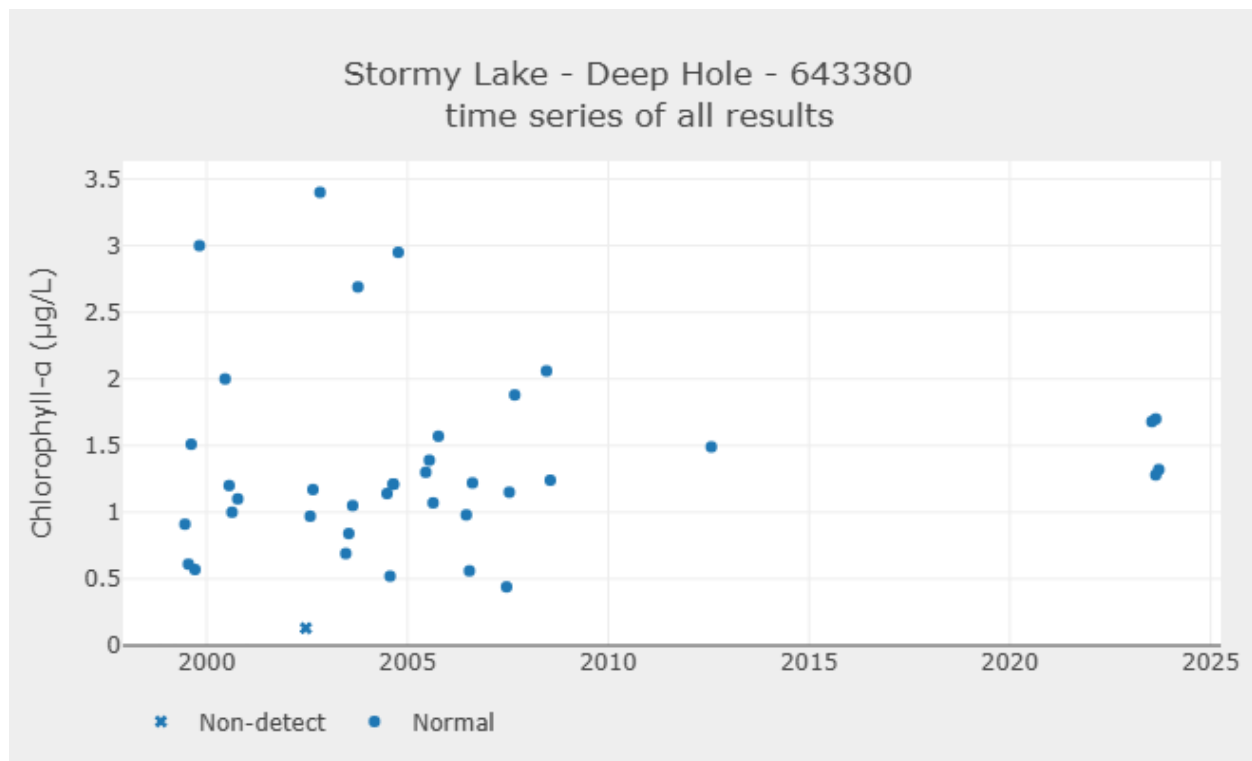
Figure 6. Stormy Lake chlorophyll *a* data from 1999-2023. No statistically significant trend was detected. Sampling shows the 8 ug/L threshold for fish & aquatic life and the 20 ug/L threshold for recreation criteria have not been exceeded. Plot generated from the Wisconsin Water Explorer.

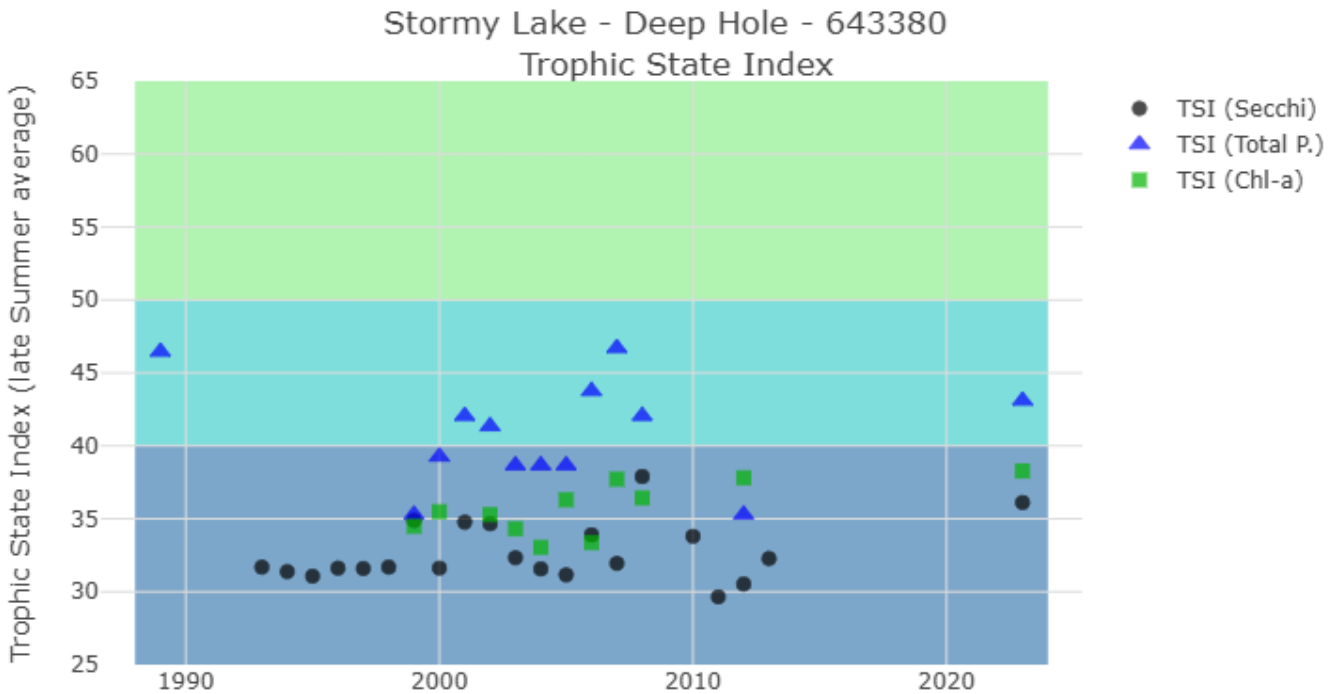
Figure 7. Stormy Lake trophic state from 1989-2023. Data indicate Stormy Lake is oligotrophic. Plot generated from the Wisconsin Water Explorer.

The trophic state of Stormy Lake, based on total phosphorus, chlorophyll *a*, and Secchi depths is generally oligotrophic as sourced from late summer averages. See trophic state graph for historic data below in figure 7.

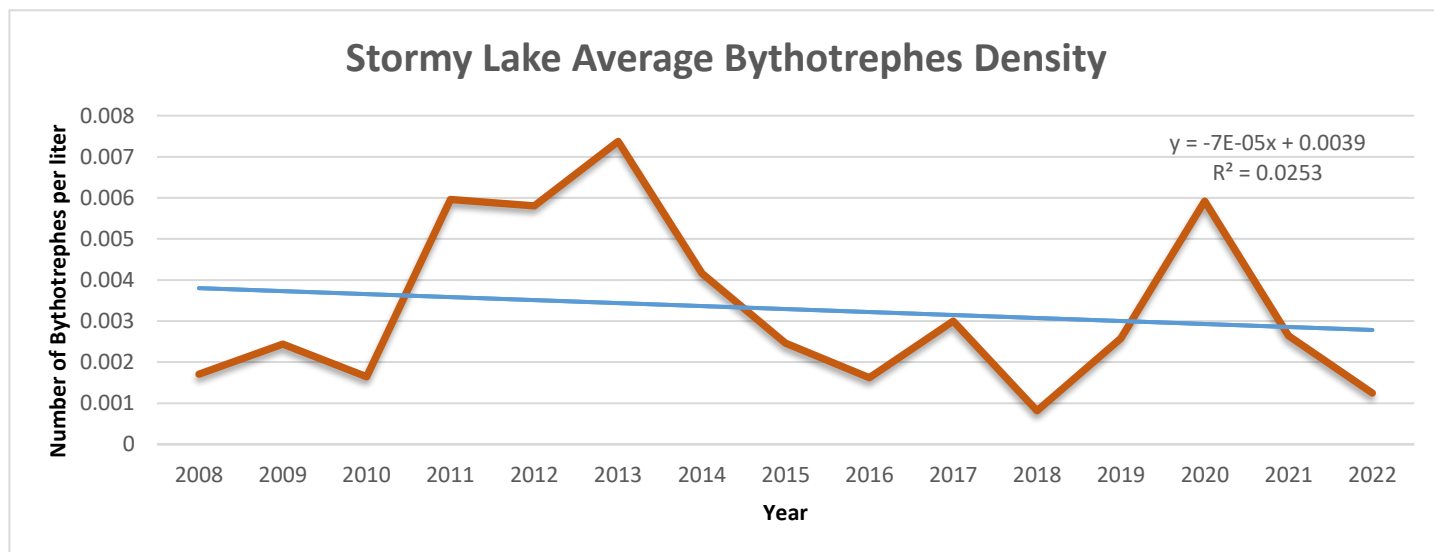
Figure 10. Density of spiny waterfleas as determined by Trout Lake Station staff (Warden 2022).

Spiny waterfleas (*Bythotrephes longimanus*) were not surveyed in 2023 because they are already verified in the lake. However, Trout Lake Station staff had shared their previous data through 2022 on spiny waterflea density and trends – see figure 10. Spiny waterfleas are an invasive plankton. The main concerns with spiny waterfleas are they have been shown to decrease water clarity in some systems by consuming too many plankton that are algae grazers (Walsh et. al. 2016); and their presence can lead to walleye stunting in their first year of life (Hansen et. al. 2020) as the young fish are not able to consume the spines. While the density of spiny waterflea has been variable since

it was quantified in 2008, linear regression from 2008-2022 data does show a decreasing trend (Warden 2022).

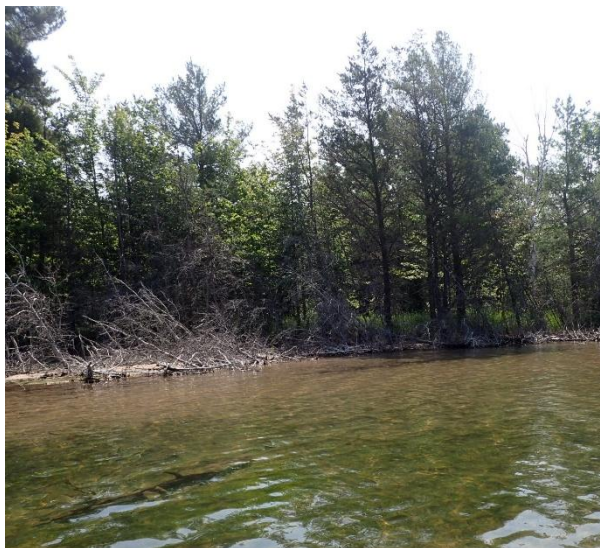
Figure 11. Wood in the water like these down trees on Stormy Lake provide structure for fish, basking spots for turtles, as habitat for insects and other invertebrates that fish eat.

The density of 6.43 logs/miles can anecdotally be considered very low. For perspective, a study by Christensen et. al. found 345 logs/mile on undeveloped lakes locally (Christensen et. al. 1996). To confirm their findings, one undeveloped lake sampled by Vilas County Land & Water had 341 logs/mile. Wood in the lake offers natural complex fish habitat and a source of ecological carbon. Riparian landowners that are interested in increasing wood in the lake can work with either Vilas County Land & Water Conservation or the DNR Fisheries Biologist for recommendations.

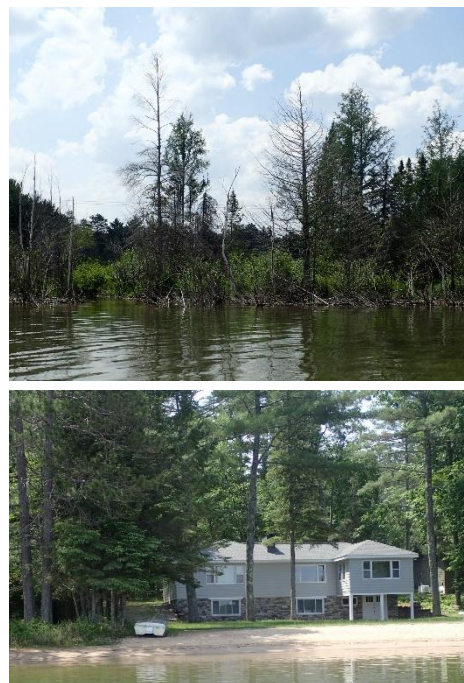
Figure 12. Some parcels had lower canopy percentages in the 35 ft riparian area because of wetlands; but most parcels with low canopy percentages occurred from clearing the riparian area for lawns, beaches, or views of the lake.

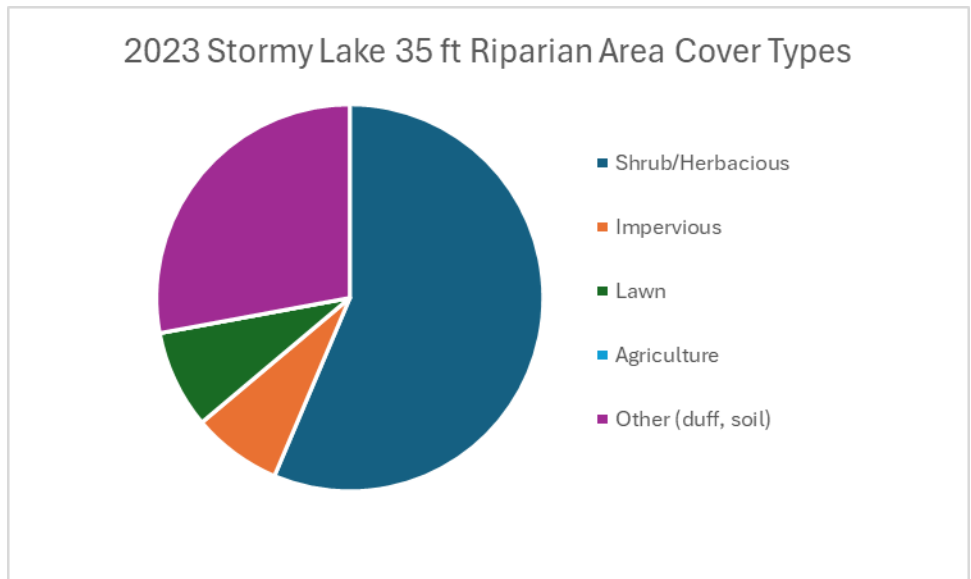
Figure 14. Ground cover type in Riparian Buffer Area (35 ft. inland from shore) on Stormy Lake, 2025.

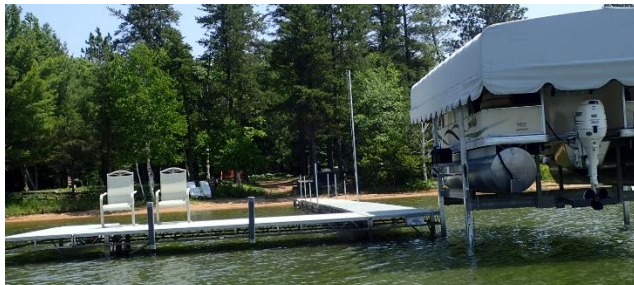
Figure 15. Dock density on Stormy Lake was 27.41 docks/mile. Development, as reflected by counting docks, has been shown to have negative effects on fish diversity if greater than 16 docks/mile (Jacobsen et.al).

these areas are typically protected by County Zoning and DNR regulations, and permits are often required to modify or place new structures in these areas. In Stormy Lake boats lifts were the most common structure followed by piers. Ten docks or less per kilometer (16 docks/mile) of shoreline, as a reflection of shoreline development, has been shown to be a threshold of maintaining high fish diversity in Minnesota (Jacobsen et. al). Stormy Lake's pier density was 27.41 docks/mile of shoreline, exceeding this figure.

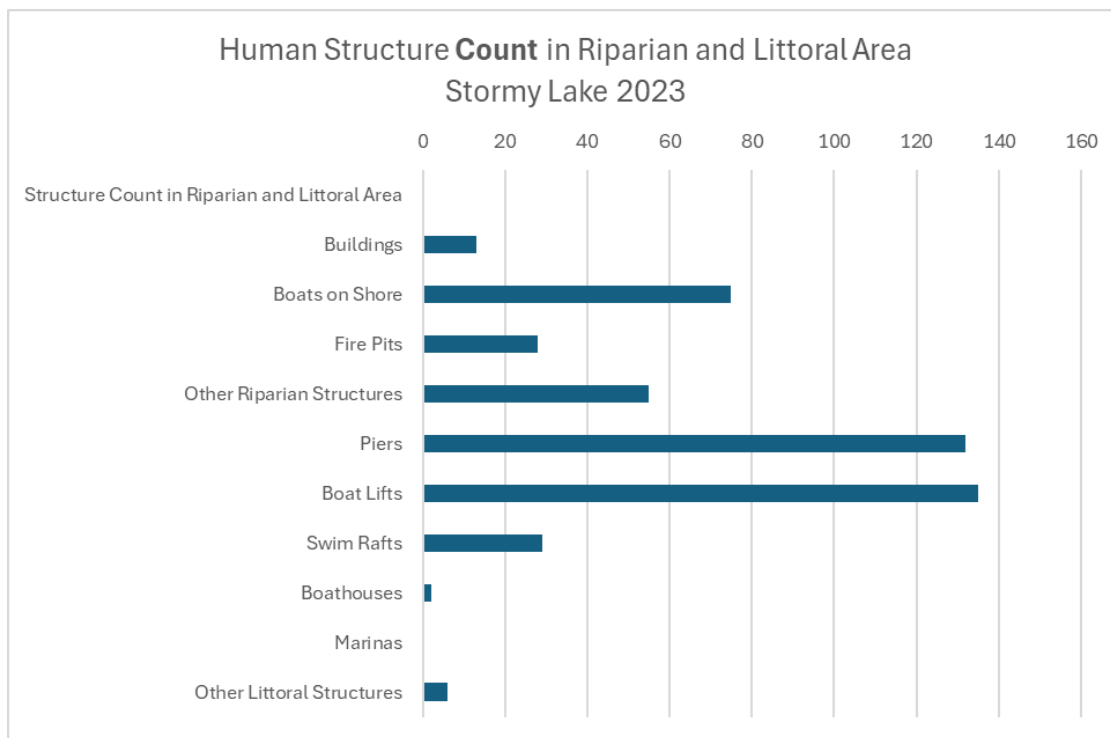
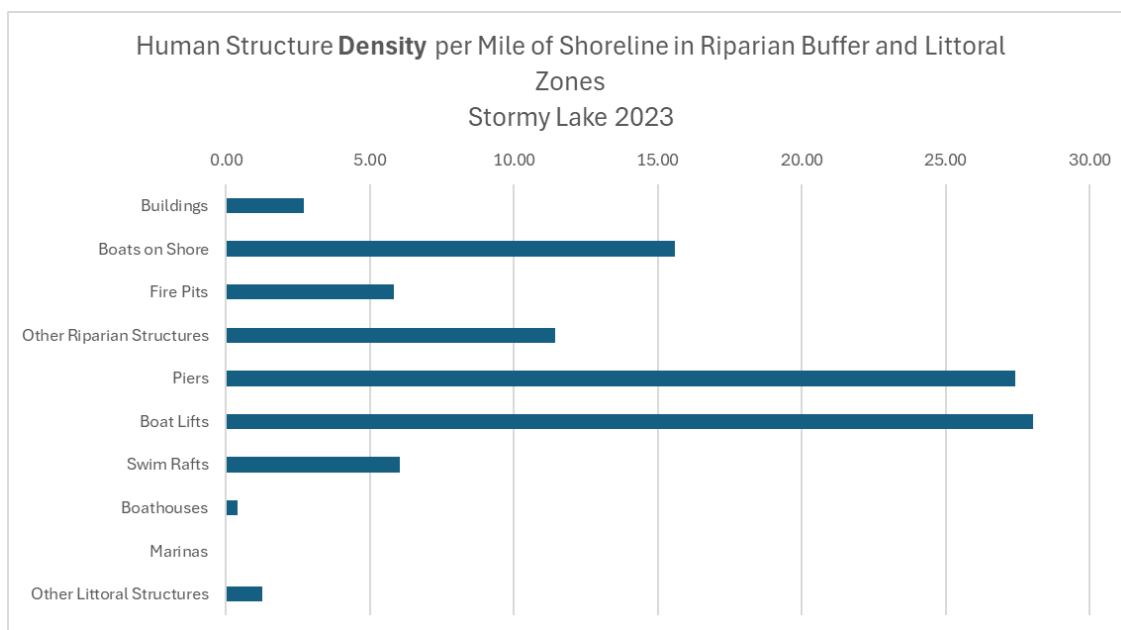
Figure 16. Number (top) and density per mile of shoreline (bottom) of human structures documented in the Riparian Buffer and Littoral Zones on Stormy Lake 2023.

Several human structures or modifications were noted in the Riparian and Littoral Zones. See figure 16 for Human Structures in Riparian Buffer and Littoral Zones Charts. Because of their ecological importance,

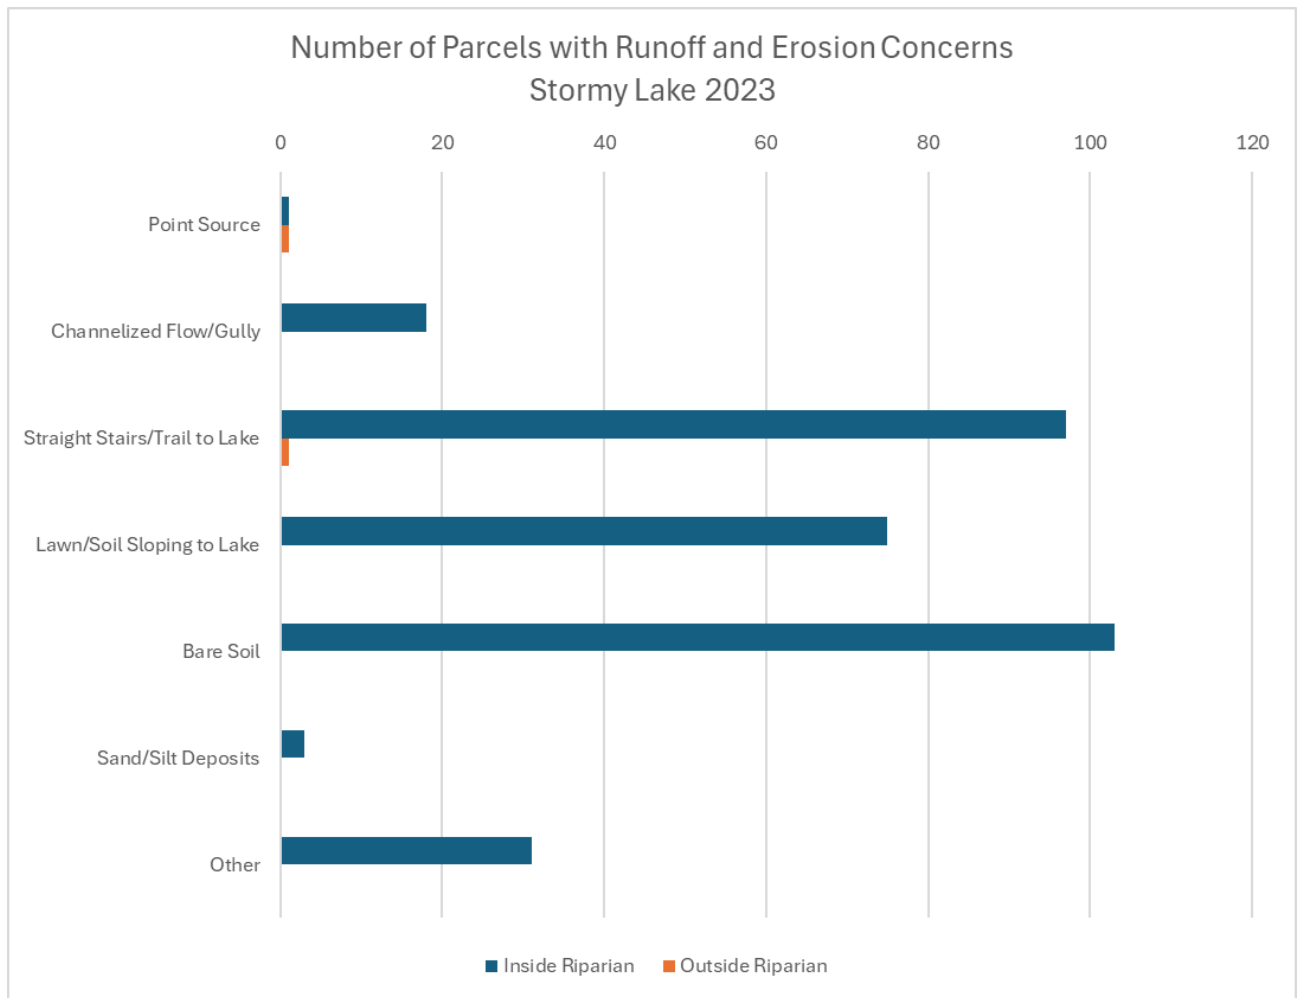
Figure 17. Number of parcels with runoff and erosion concerns in Riparian Zone and Outside Riparian Zone on Stormy Lake 2023. Of the 140 parcels, 128 had erosion or runoff concerns (91%).

Of the 140 parcel surveyed, 128 had runoff and/or erosion concerns. Two parcels had point sources (likely rain water discharges); 98 parcels had straight stairs or trail to the lake; 75 parcels had either lawn or bare soil sloping to the lake; and 103 had areas of bare soil. Often bare soils was due to beach areas or eroding slopes. See figure 17.

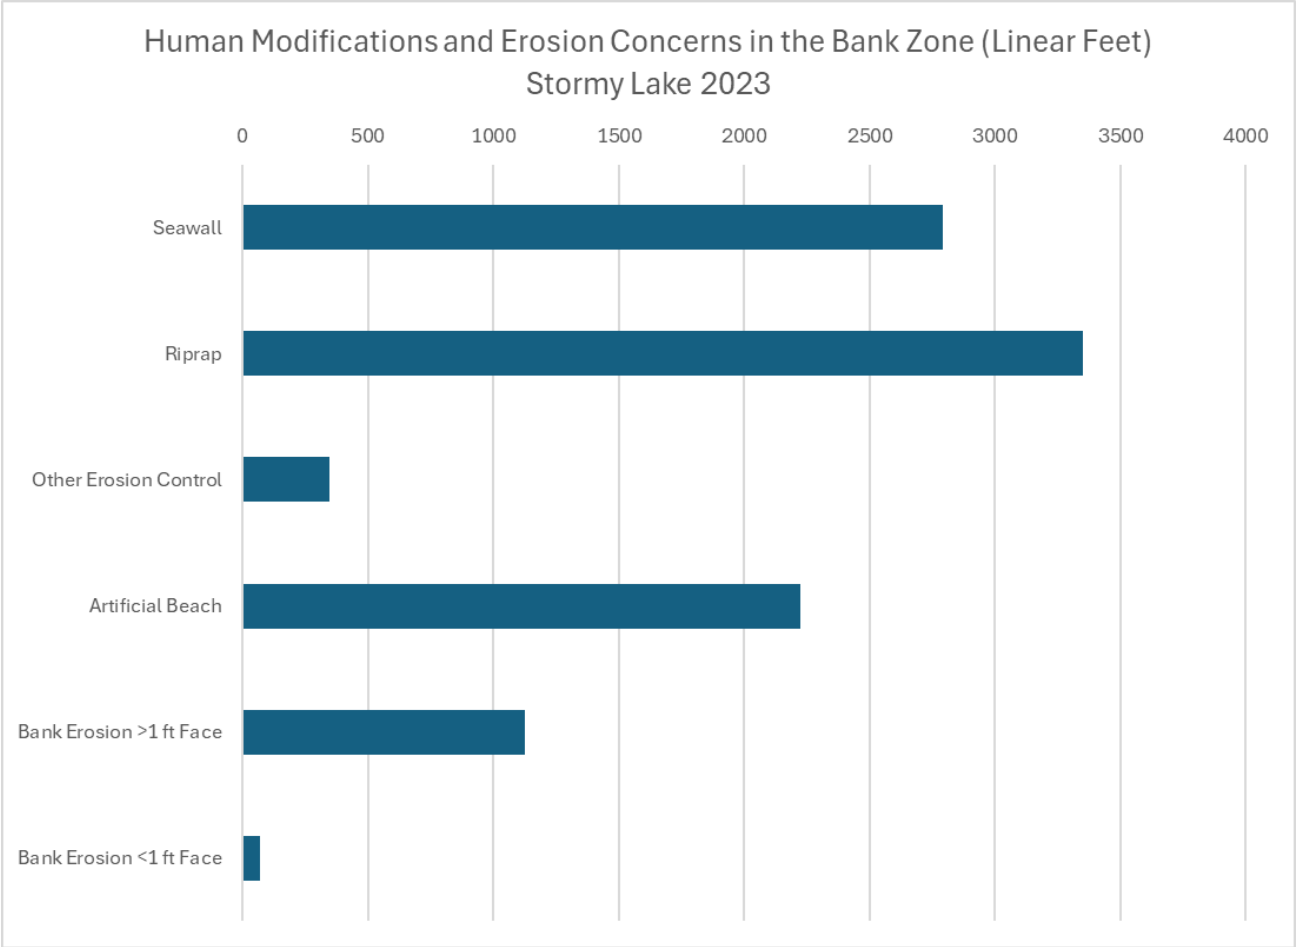
Figure 18. Linear feet of human modifications to the bank zone on Stormy Lake 2023.

While these riprap or seawalls might have landscaping appeal, they do detract from providing natural wildlife habitat. Riprap and seawalls create difficult transitions for certain wildlife – imagine being a turtle trying to access land from the water. They can also deflect wave energy and scour the nearby lake bottom or adjacent shorelines. Note that installing, repairing, or replacing these structures often requires DNR permits. There is a riprap permit exemption if particular specifications are met with the riprap design. However, many parcels appeared to use rocks in their riprap that would be larger than the current standard (6-48 inch diameter rock); and were placed at slopes much steeper than the current standard (1 ft horizontal to 1.25 vertical). When repairing or replacing riprap, make sure to review allowable standards for sizing and slope of riprap. These standards are in place allow for the best wildlife habitat while minimizing ice shove problems. Overall, the bank zone of Stormy Lake is modified and/or eroding more than many other lakes surveyed by Vilas County Land & Water. Shoreland lengths of these human modifications to the bank zone appear in figure 18.

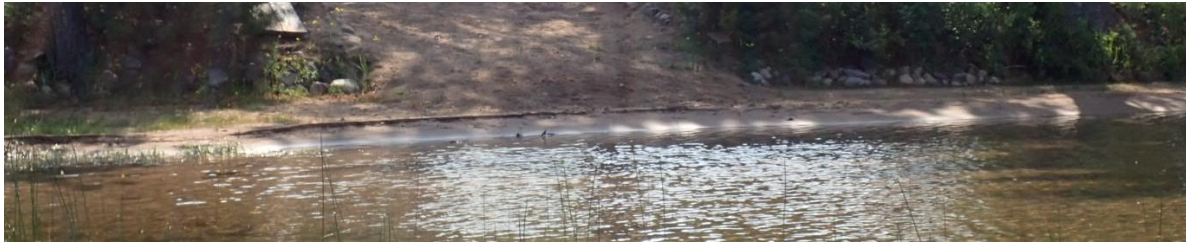
Figure 19. Other erosion control structures encountered in the bank zone on Stormy Lake included timbers or logs to hold back beaches or lawn.

Besides typical bank erosion control methods like rock riprap or seawalls, Stormy Lake had 345 ft of “other erosion control structures”. Most common was timbers to hold beach or lawn in place at the bank. See figure 19. Most often, addressing shoreline erosion issues on the bank requires DNR permits, and may necessitate engineering. Before attempting bank stabilization do-it-yourself fixes, check with Vilas County Land & Water Conservation on what is likely to work for your site, access low-cost or free engineering input if needed, and learn what permits would be required. On low wave energy sites, simply re-vegetating the bank area is enough to stabilize the bank and slow erosion.

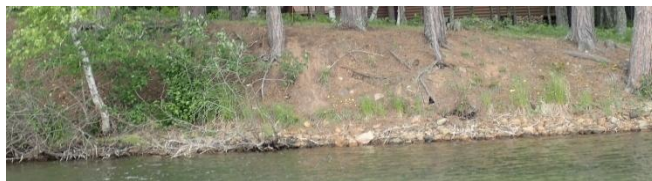
Figure 20. At least 23 properties with slopes down to the lake showed significant erosion above the bank.

The soil around Stormy Lake is quite sandy, and staff found at least 23 parcels with significant hillside erosion above the bank. See figure 20 for some example photos.

Bare Soil map. Eroding soil adds extra phosphorus and sediments into the water and degrades water quality. Staff from Vilas County Land & Water Conservation are able to do site visits, recommend solutions, and in certain instances offer grant fund reimbursement for installing best practices. Contact Cathy Higley from Vilas County Land & Water Conservation 715-479-3738 or cahigl@vilascountywi.gov or Quita Sheehan at 715-479-3747 or mashee@vilascountywi.gov for assistance, questions, or possible funding.

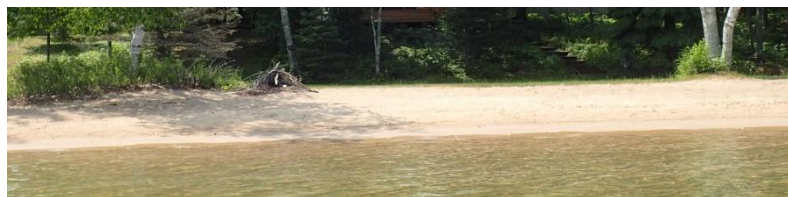
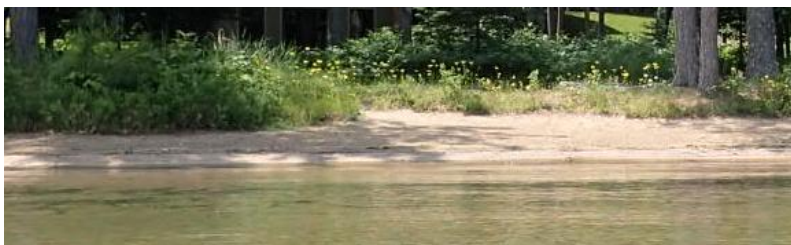
Figure 21. At least 48 properties had artificial beaches. Some beaches were due to adding sand, but more were due to removing riparian vegetation to expose the sandy soil.

At least 48 parcels had artificial beaches (either by adding sand or removing riparian vegetation). Stormy Lake is surrounded by sandy soil with little structure to it – sometimes referred to as the Conover sugar-sand. This soil is relatively easy to remove vegetation above the ordinary high water mark to create a beach area. Beach creation and maintenance is not a best practice because beaches are erodible areas (and therefore add nutrients into the lake) and do not

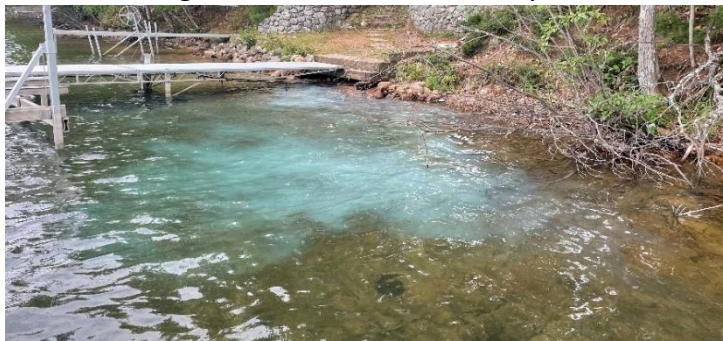
Figure 22. Milky white water adjacent to shore. It is unclear what caused the water to be this color.

“milky white water”. After consulting with a few lake biologists, it is still uncertain why the water is this color. Most likely options could be decaying blue-green algae; or wastewater discharge; or bacterial activity. See figure 22.

While surveying on August 23, 2023, staff found an area of

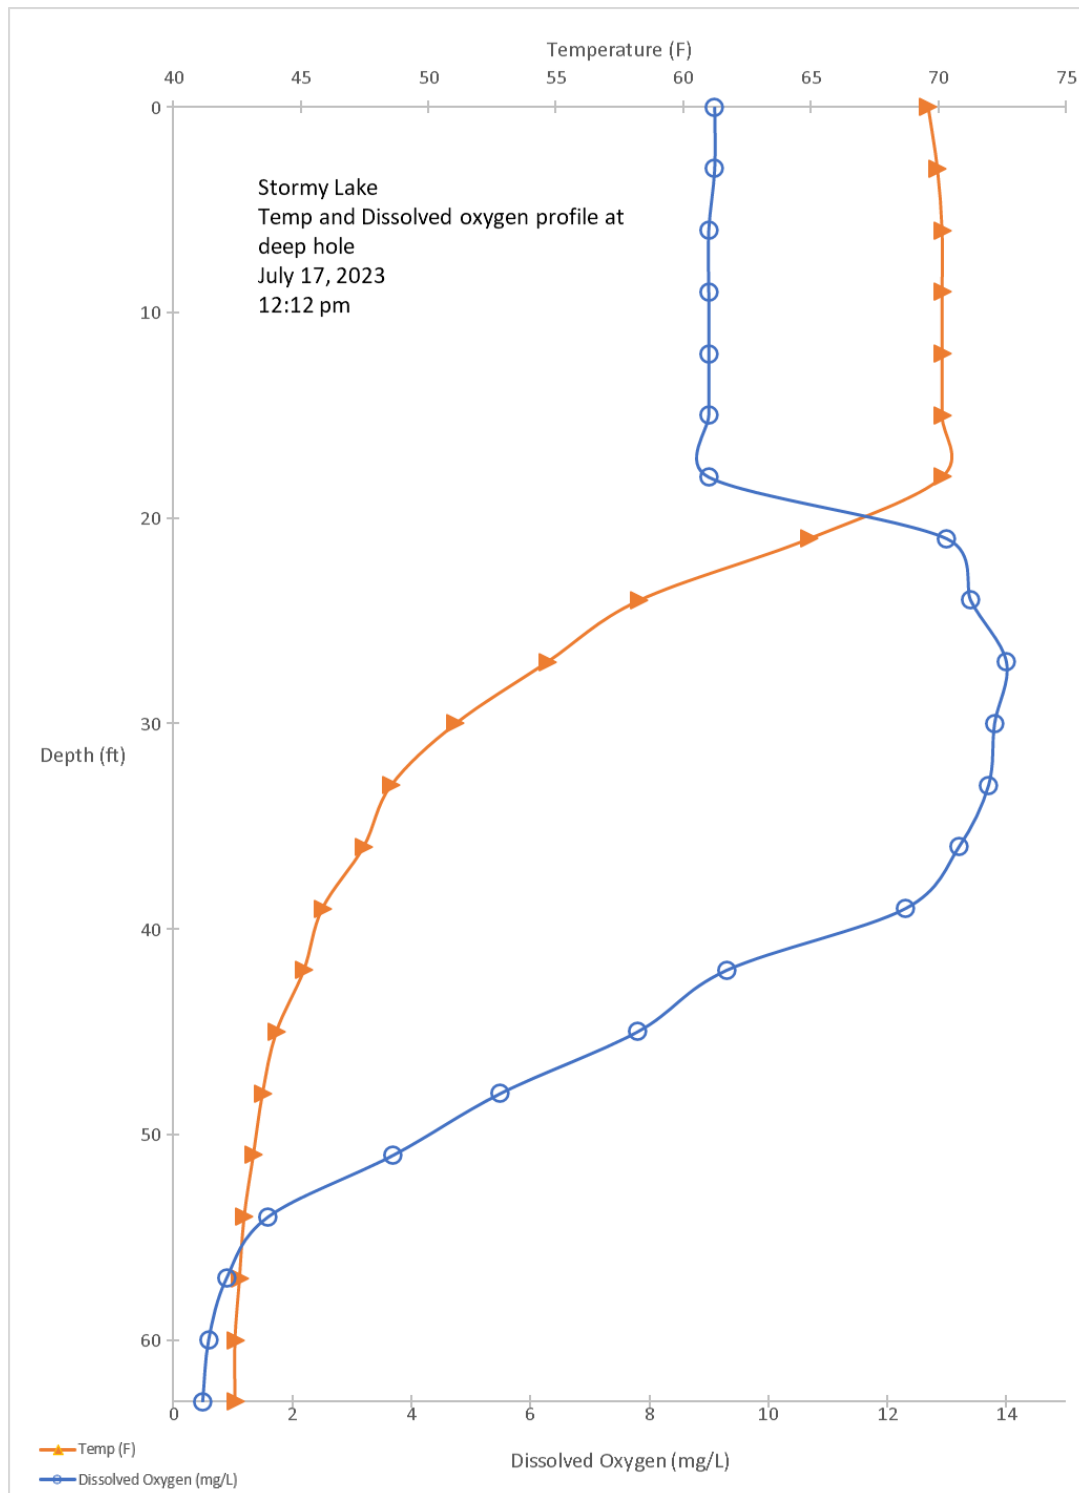
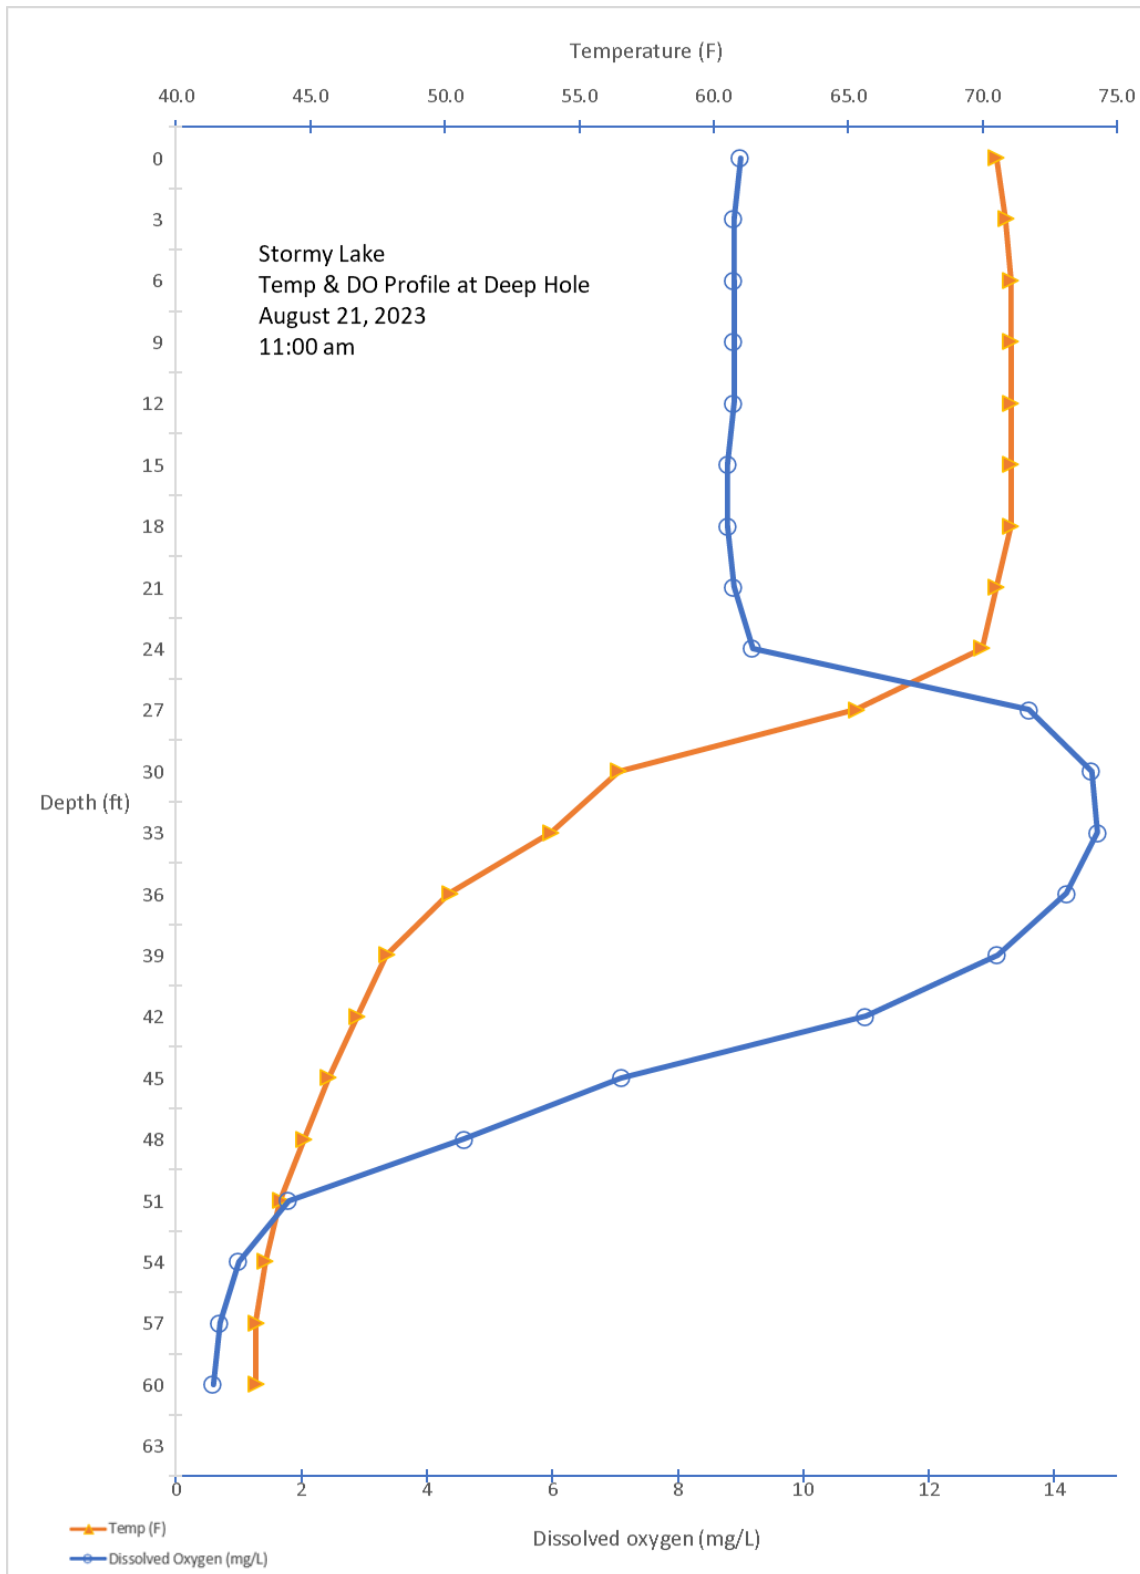
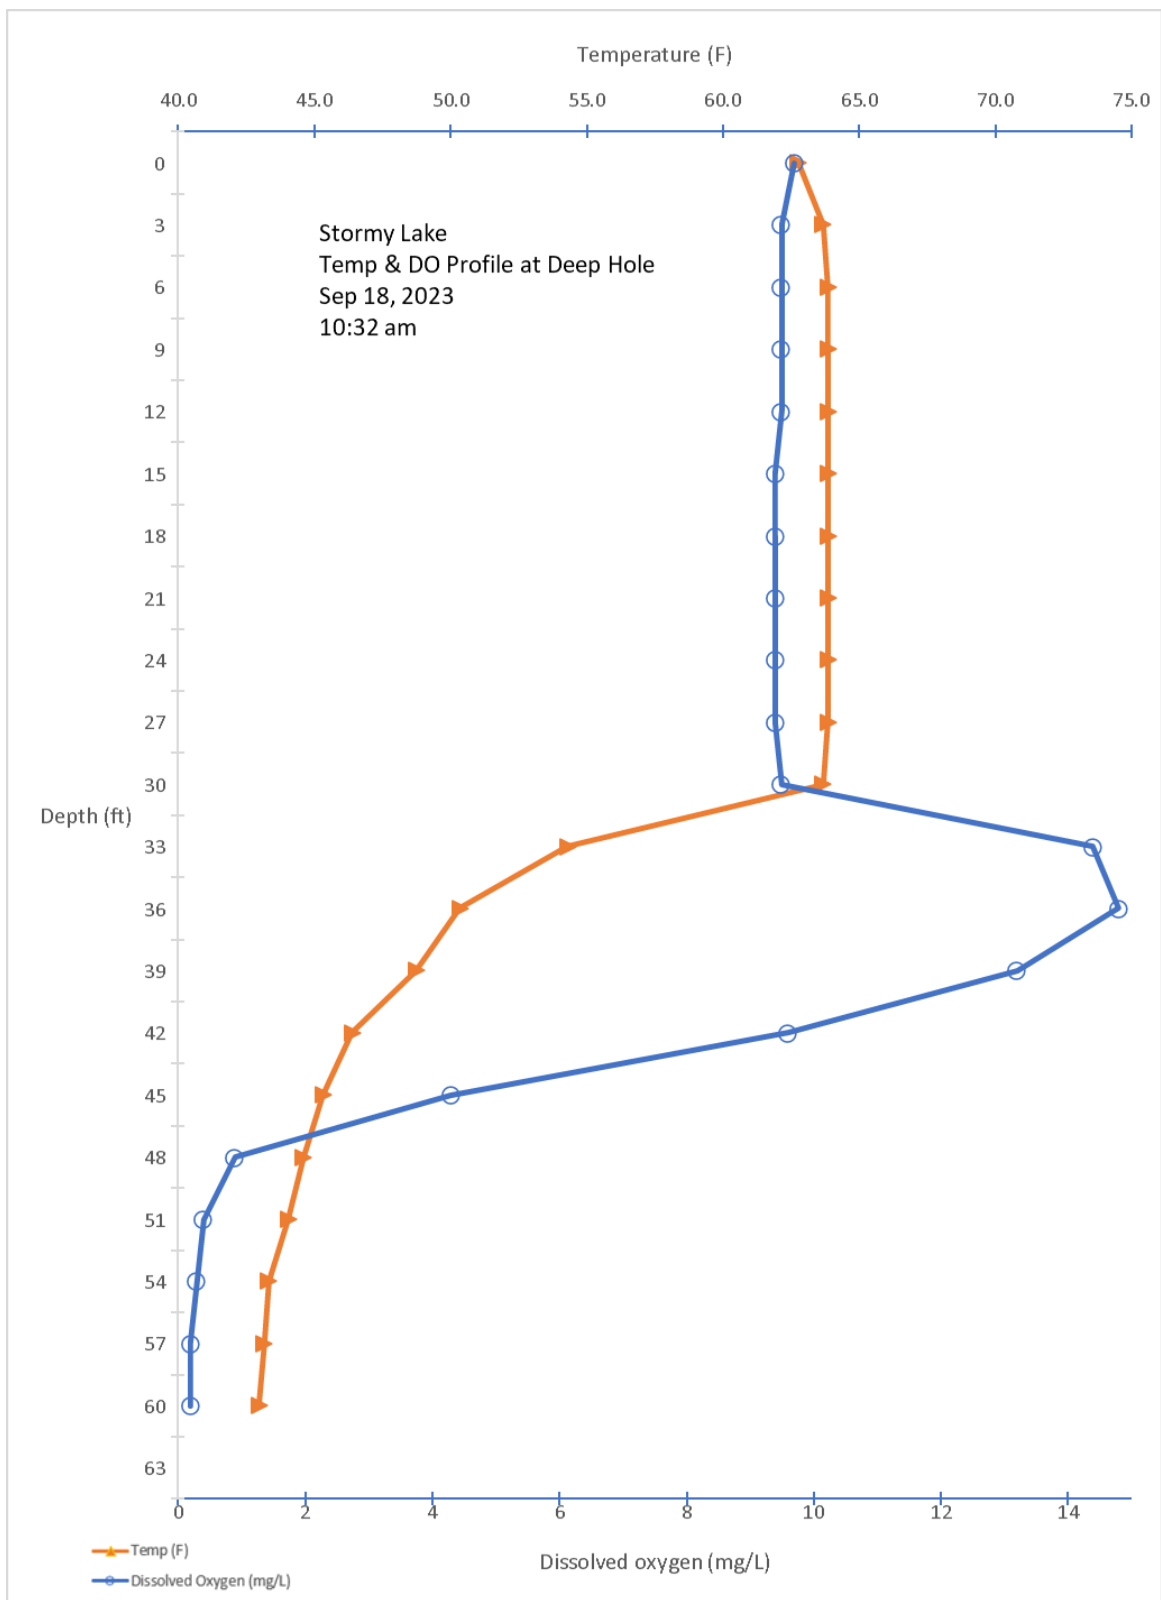
Figure 24. July, Aug, and Sep 2023 dissolved and temperature profiles for Stormy Lake.

The July, August, and September temperature and dissolved oxygen profiles show the lake was strongly stratified, with higher oxygen concentrations at the thermocline.

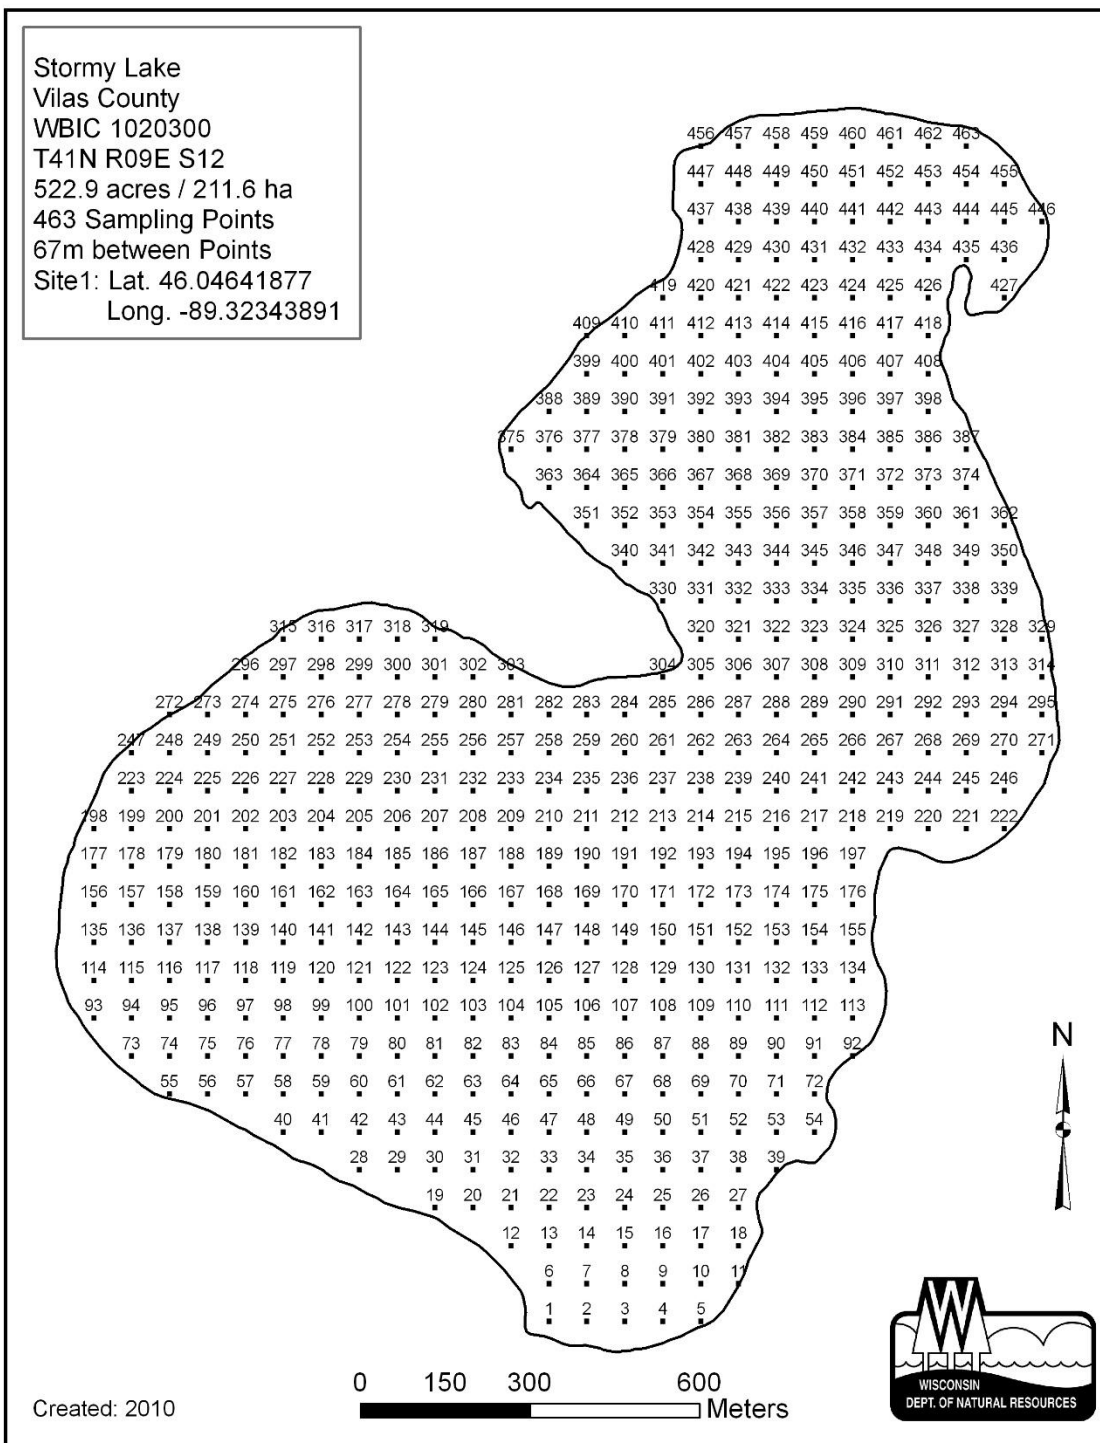
Figure 25. Aquatic plant point-intercept map for Stormy Lake. Courtesy of WI DNR.

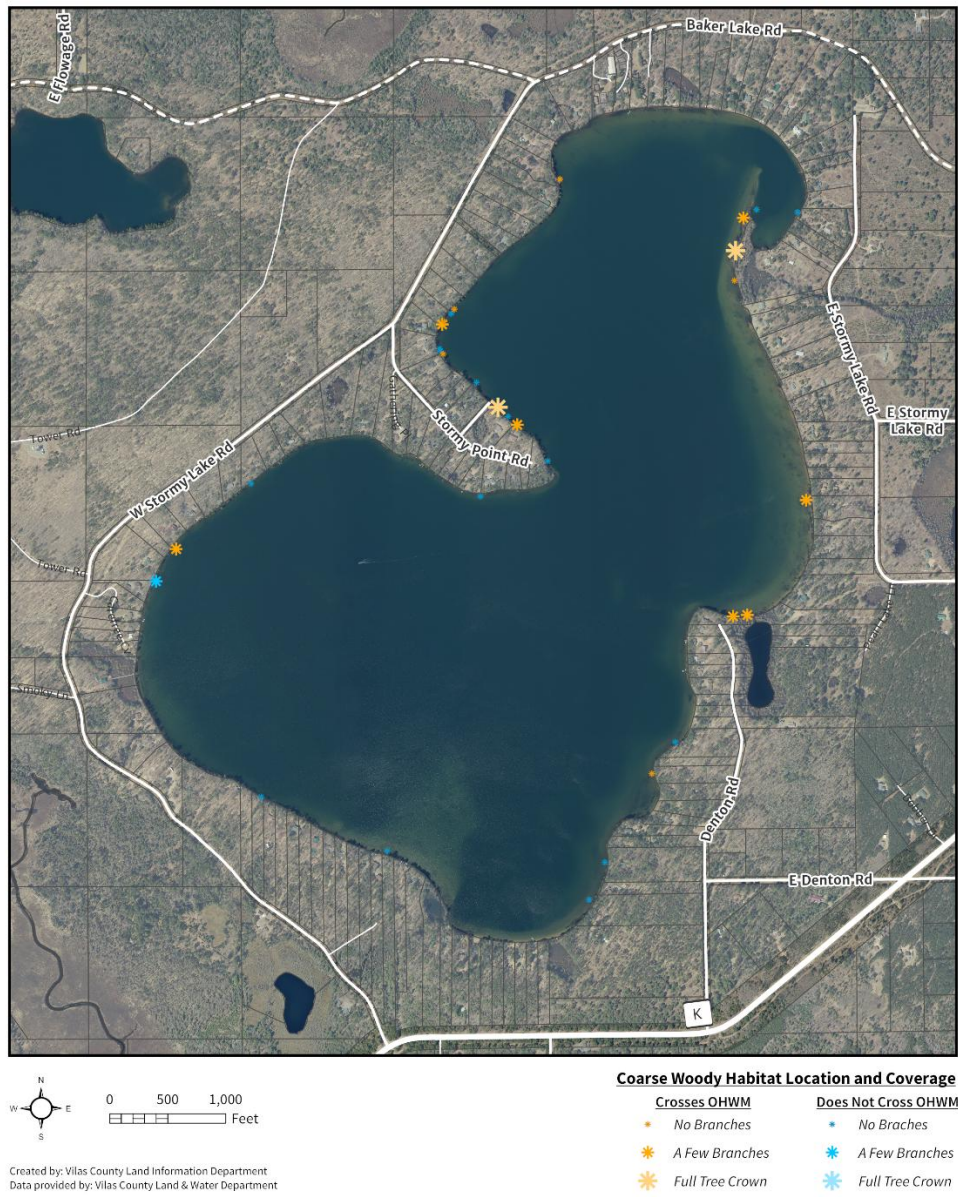
Figure 33. Coarse Woody Habitat Characterization for Stormy Lake, 2023. 6.43 logs/mile were documented.
