Stormy Lake 2023 Lake Assessment Report

Prepared by
Vilas County Land & Water Conservation

September 11, 2025

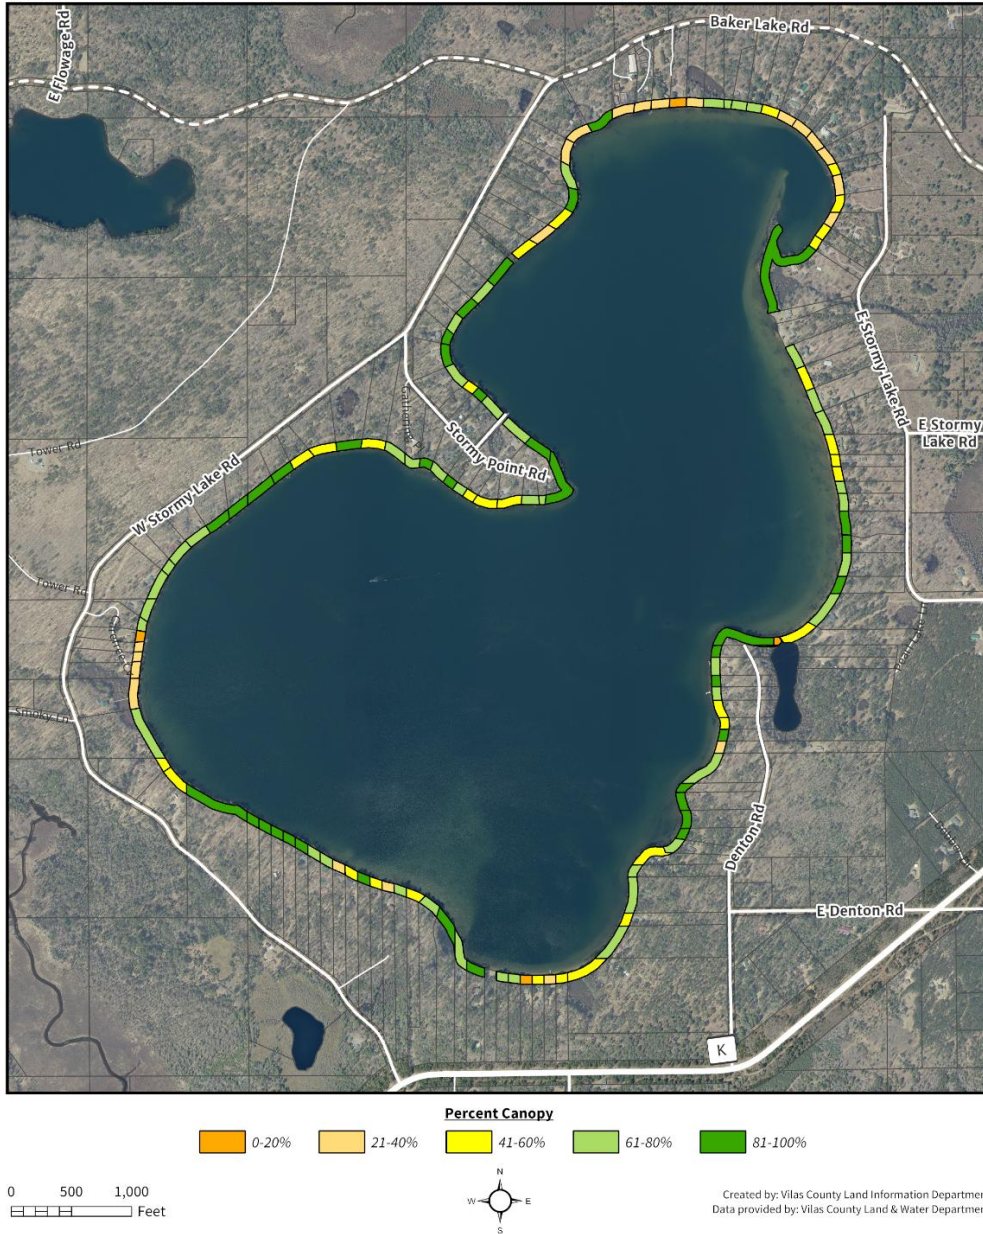
Figure 34. Canopy cover percent per parcel within 35 ft buffer area on Stormy Lake 2023.

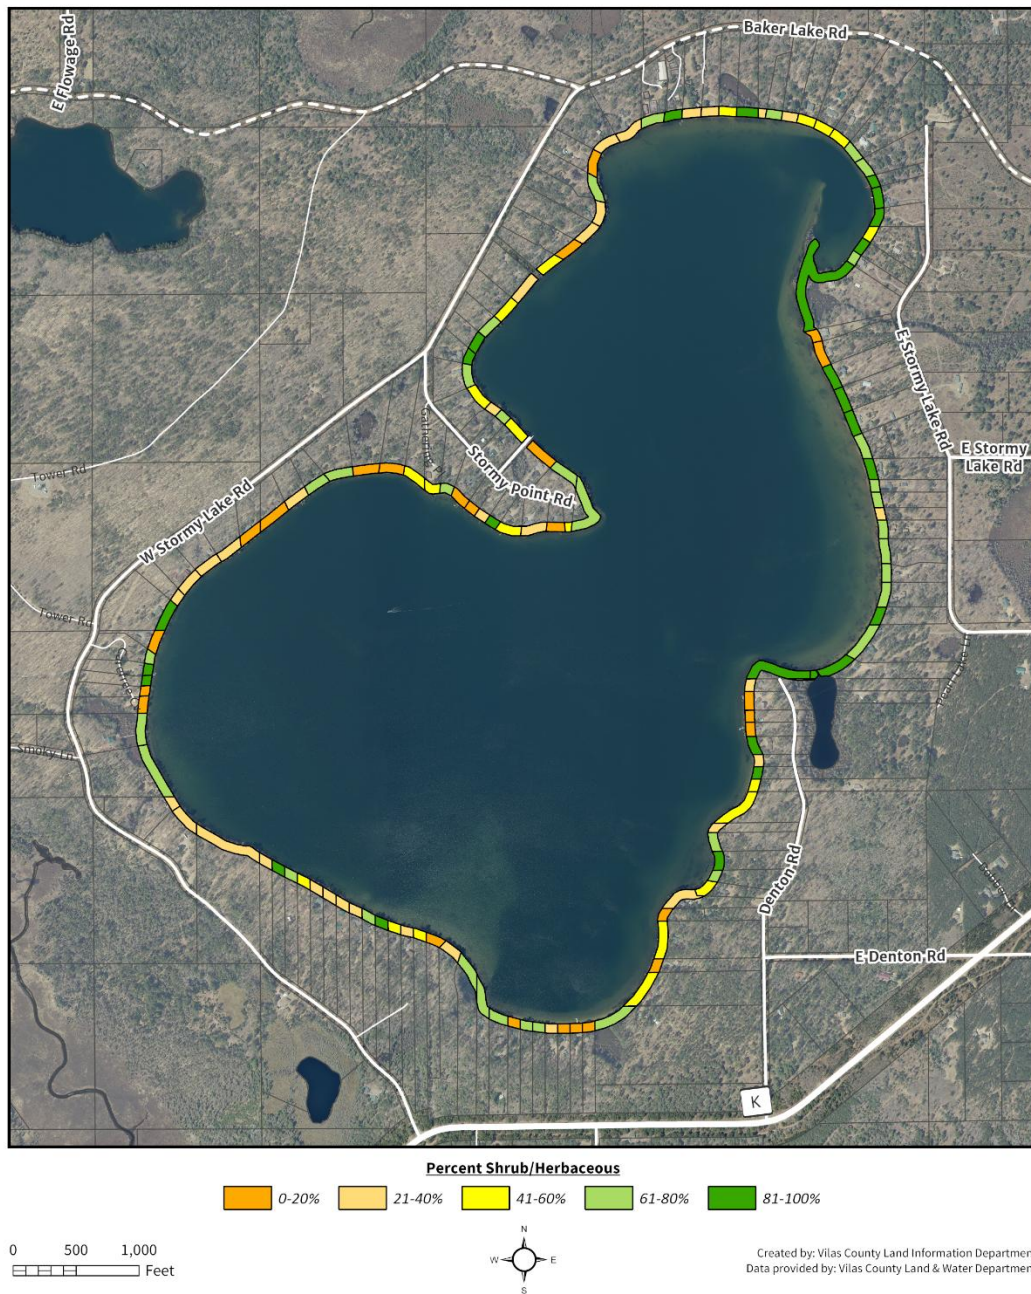
Figure 35. Percent shrub/herbaceous cover per parcel within 35 ft buffer area on Stormy Lake 2023.

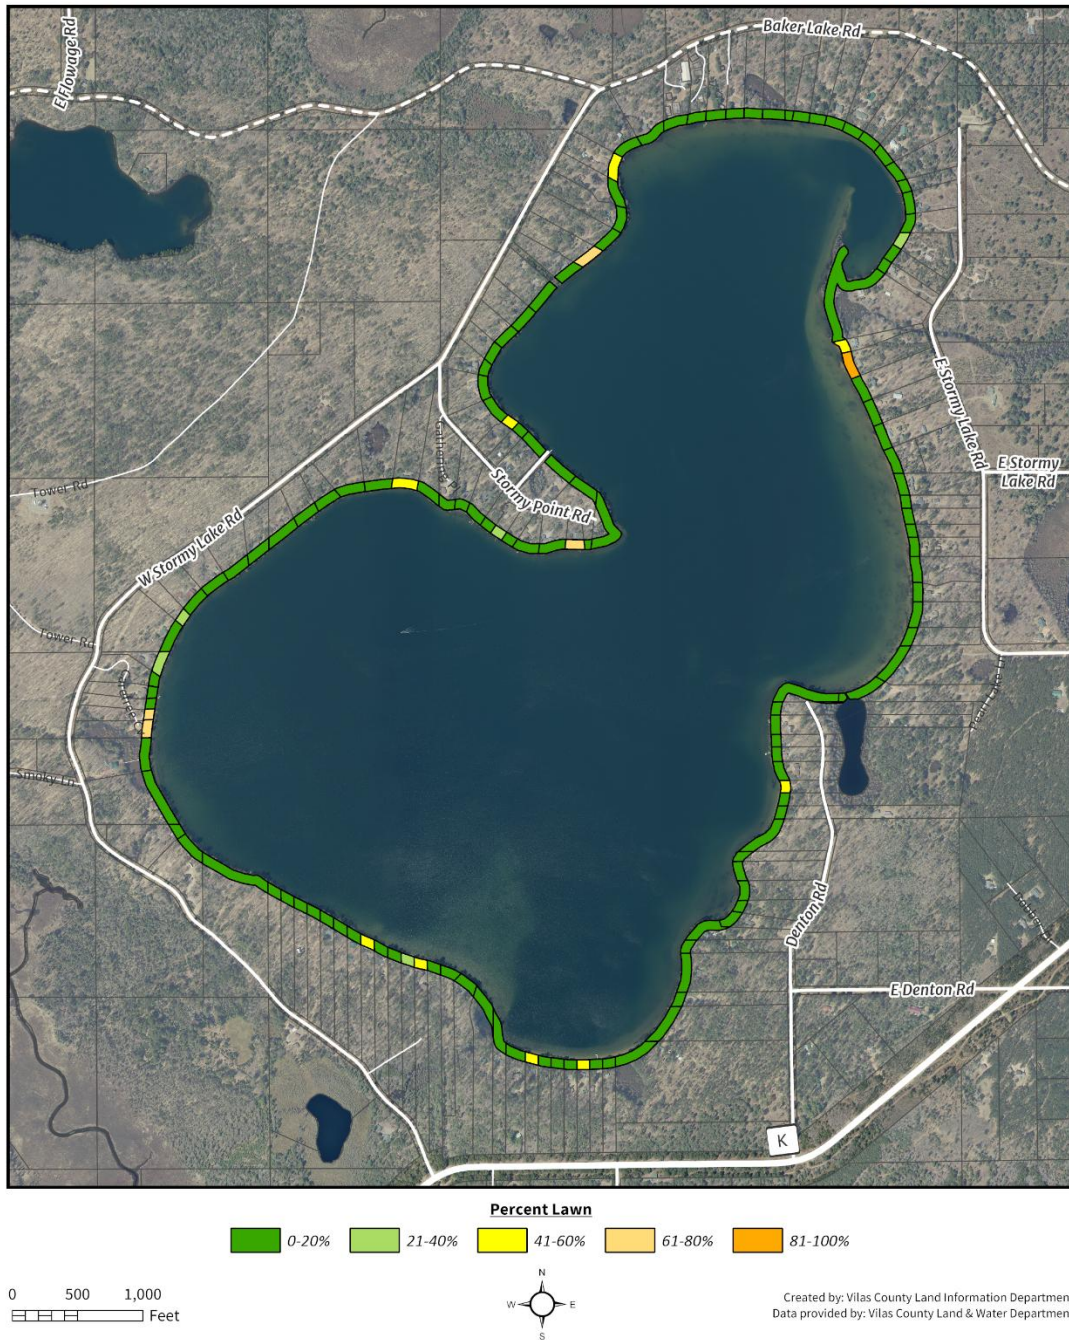
Figure 36. Percent lawn cover per parcel within 35 ft buffer area on Stormy Lake 2023.

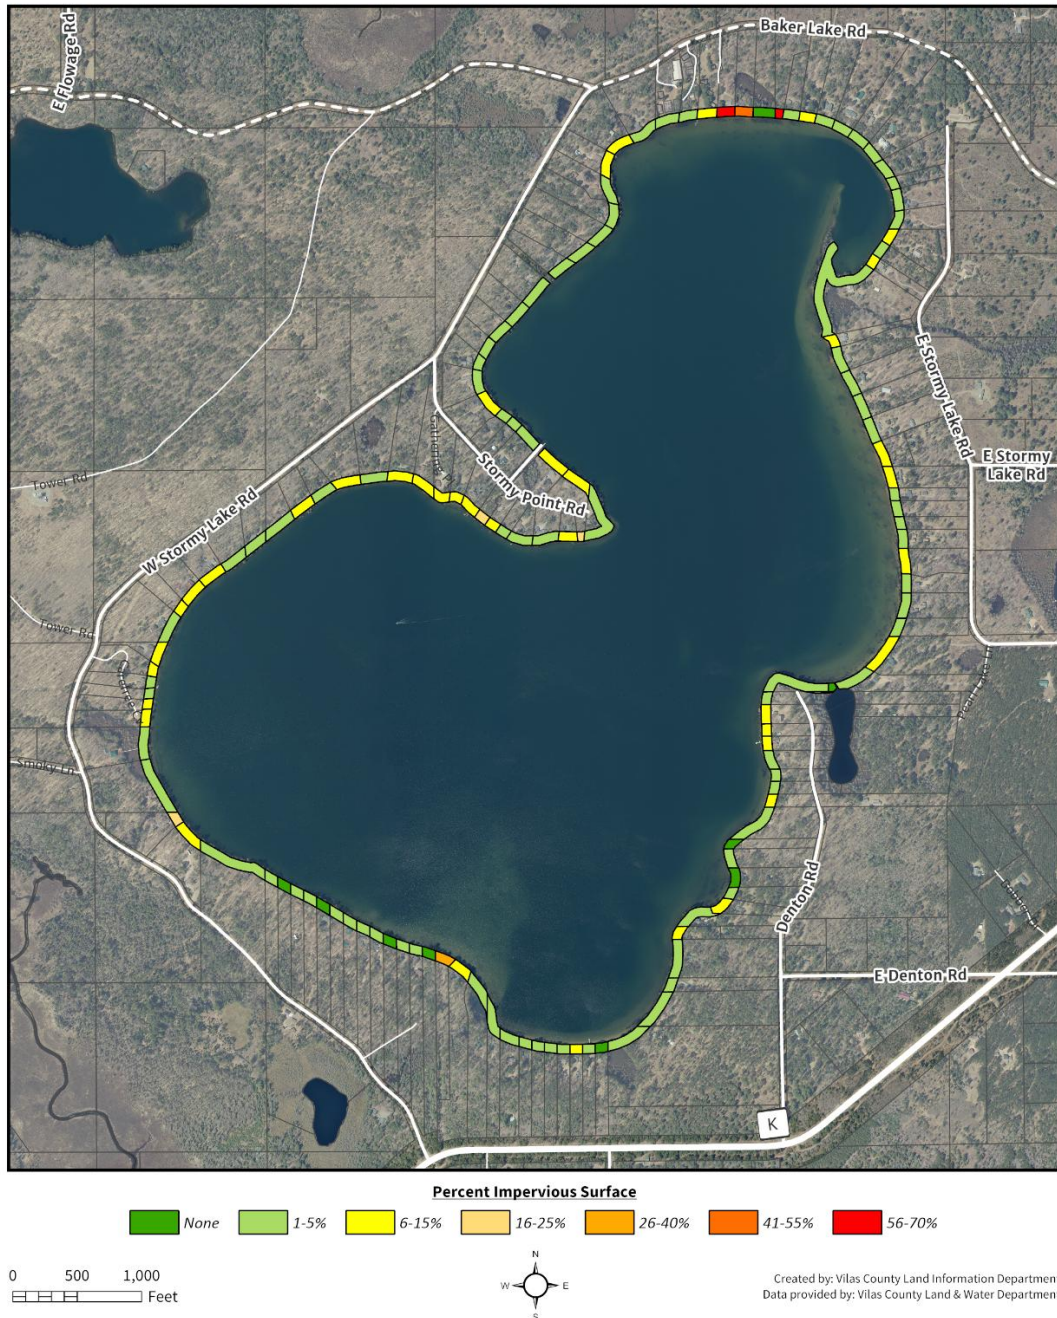
Figure 37. Percent impervious surfaces within 35 ft. riparian buffer zone per parcel on Stormy Lake 2023.

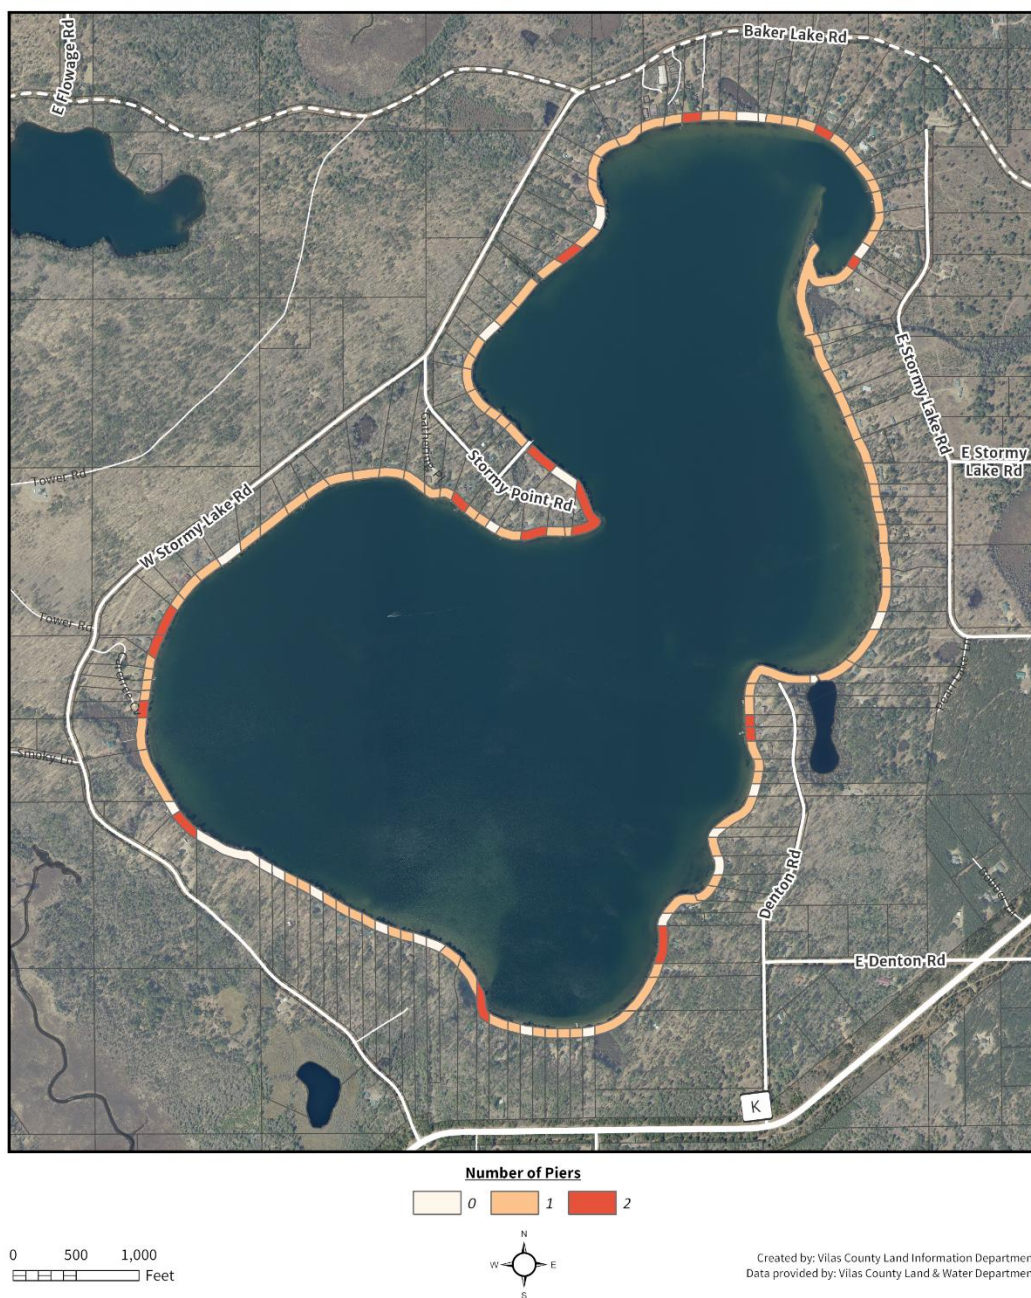
Figure 38. Number of piers per parcel on Stormy Lake 2023.

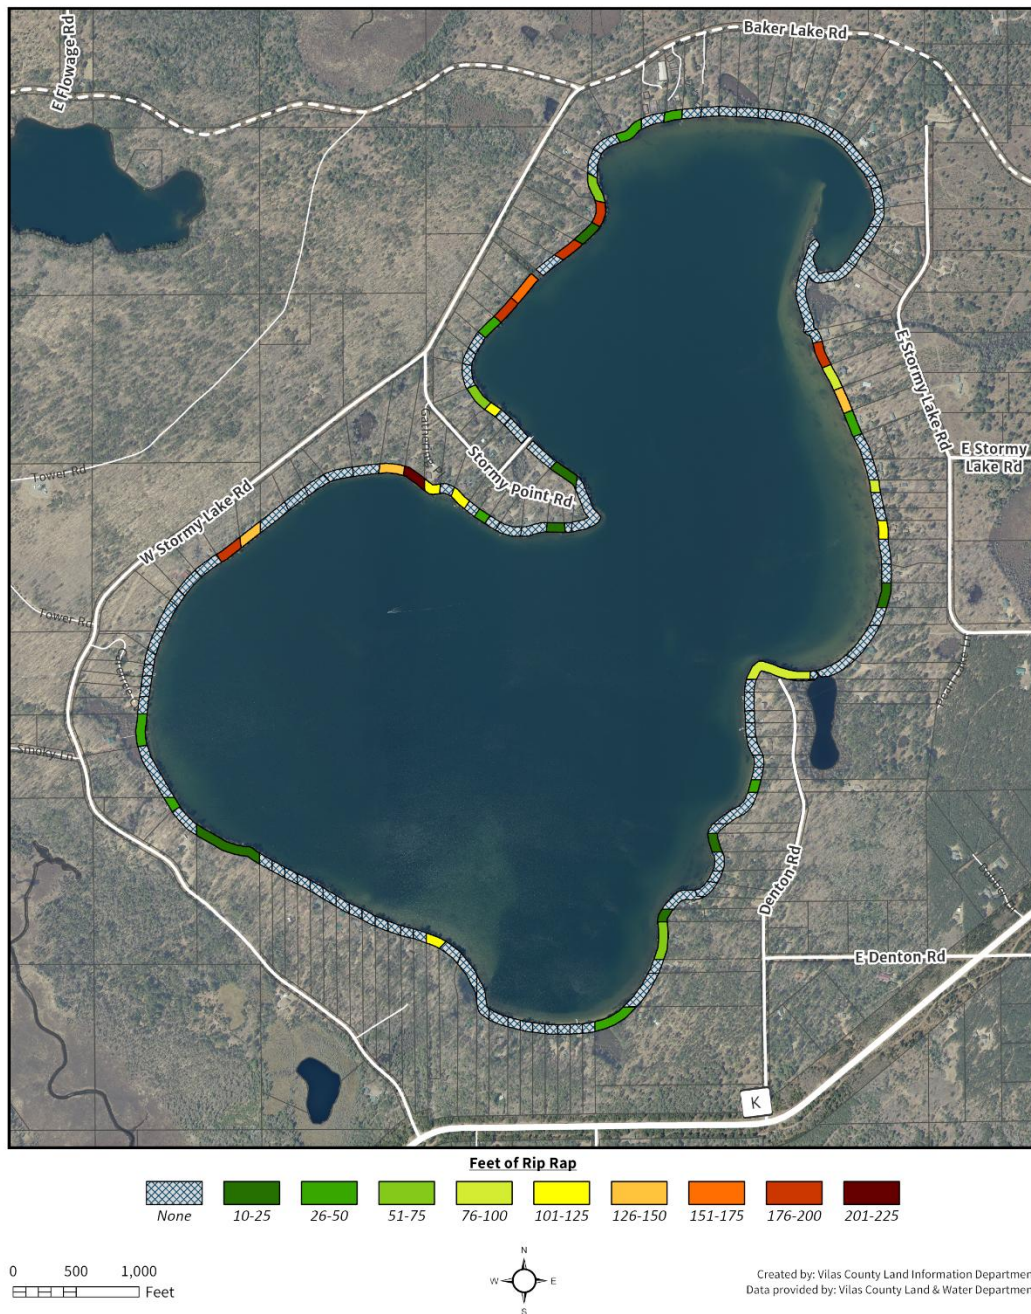
Figure 39. Feet of riprap per parcel on Stormy Lake 2023.

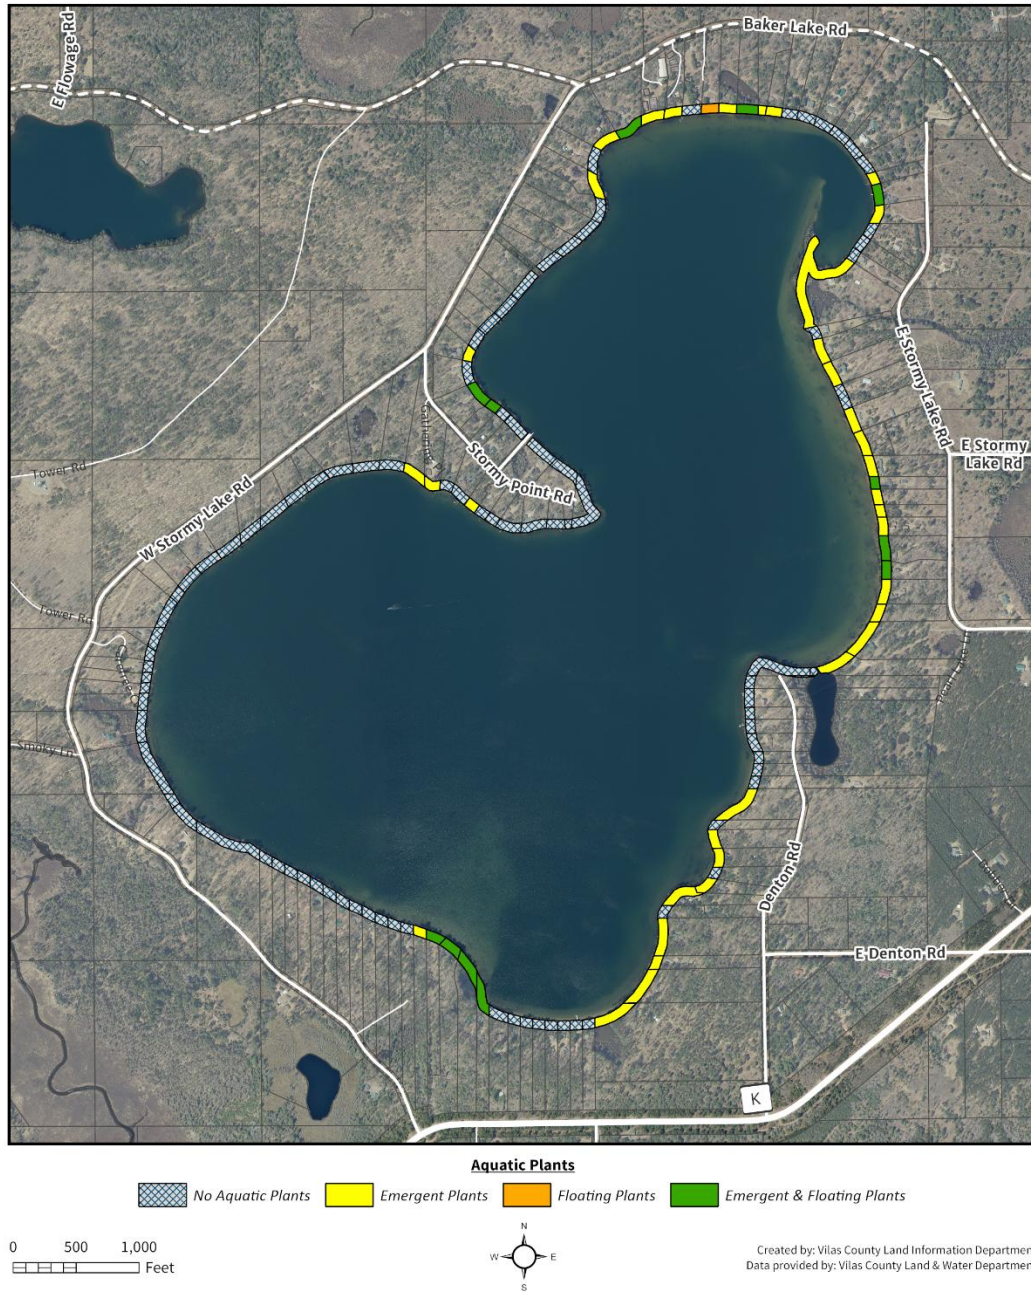
Figure 43. Parcels where emergent or emergent and floating plants were observed on Stormy Lake 2023.
